Winter ready - flood defence repairs in Cornwall

Our Asset Performance teams have been working hard to ensure that flood defence assets have been assessed and repaired for the winter. Any flood defences and equipment damaged during last winter's flooding have either been fixed, or have robust contingency plans, such as temporary defences, in place. This update details some of the many repairs to flood defence assets in Cornwall which have taken place this year.

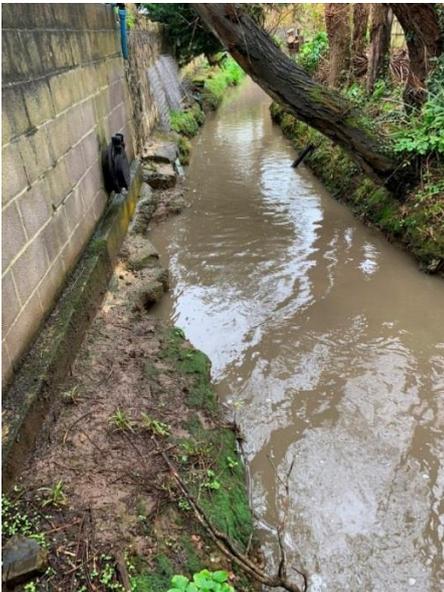
Before

Crooklets, Bude: recovery project

Protection of toe wall using gabion baskets to prevent further undermining and possible collapse, causing blockage within the Crooklets Flood Alleviation scheme.

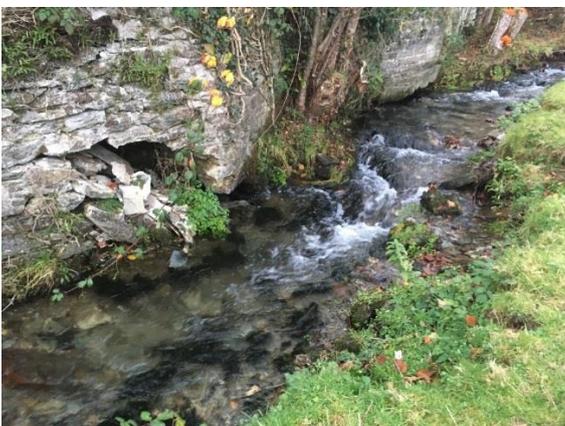
Before

Springfields, Horrabridge: recondition project

Repair of sections of bulging wall and toe erosion, upstream of an Environment Agency trash screen.

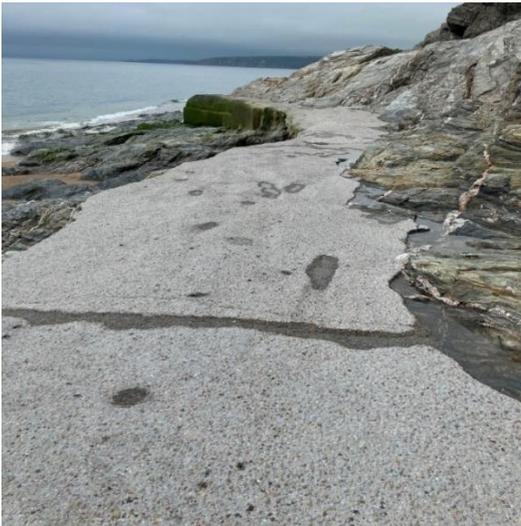
Before

Loe Bar, Porthleven: repairs to the main culvert outfall

Reducing the likelihood of blockage, allowing Loe Pool to discharge freely and preventing any backing up of water levels in the Cober that would increase the risk of flooding in Helston.

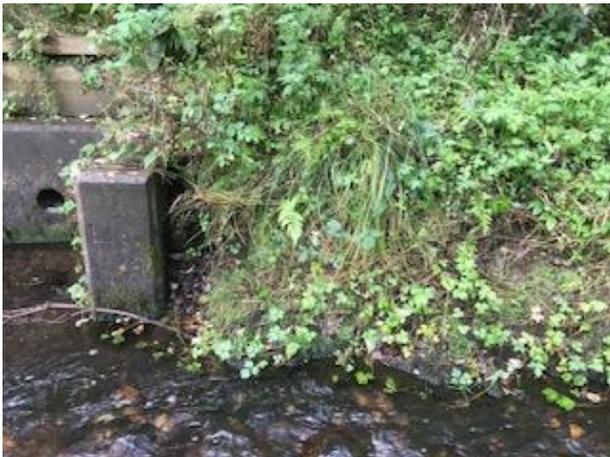
Before

New Mills flood storage dam, Truro

Concrete bag repair to erosion and large void behind step access, which may have caused potential compromise to the dam structure. Grass seed has also been laid.

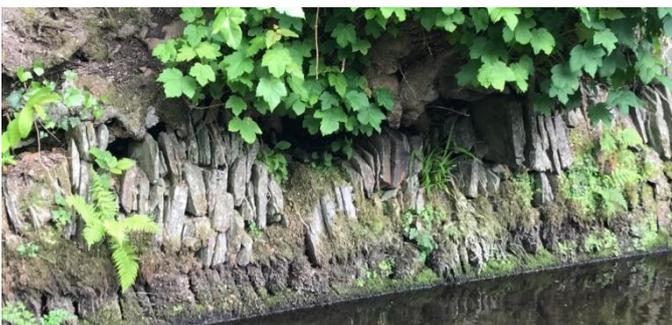
Before

Camelford wall stabilisation

Repairs to cracks along the length of wall. Rebuild of bulging stone pitching and stabilisation of wall face, which had compromised the structural integrity, with platypus soil anchors, and rock netting and underpinning to the toe along the length of the wall. A fish shelf has been installed at the toe of the wall to provide compensatory resting habitat for salmonids. Ferns will be planted along the wall face to increase biodiversity.

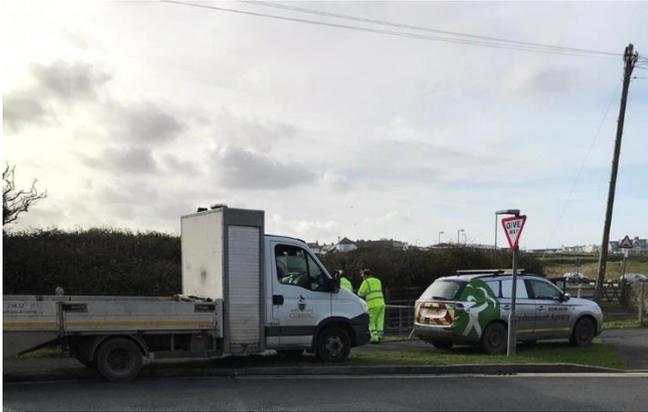
One of our external suppliers is Cormac, pictured on a trash screen check round in Bude, who we are familiarising with our asset locations and how we operate and maintain them.
